Processing the Shuttle for Flight

Preparing the Shuttle for Flight

Ground Processing

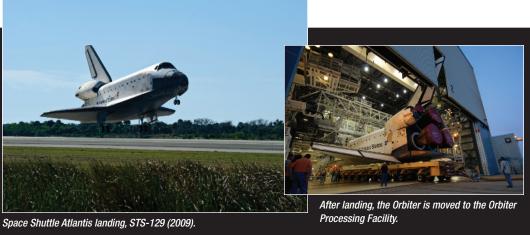
The landing-tolaunch ground operations "flow" at Kennedy Space Center prepared each shuttle for its next flight. This 4- to 5-month process required thousands of work hours and millions of individual processing steps.

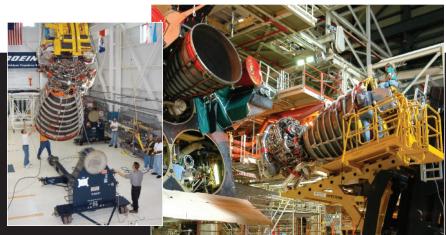
Inside the Orbiter Processing Facility, technicians process the Space Shuttle Main Engine and install it into the Orbiter.

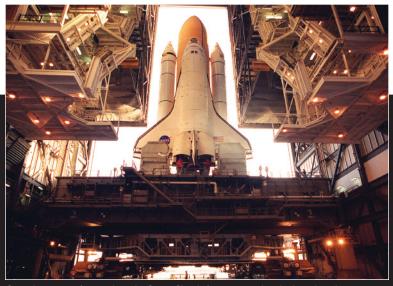
Once the process is complete, the Space Shuttle is transported to the launch pad.

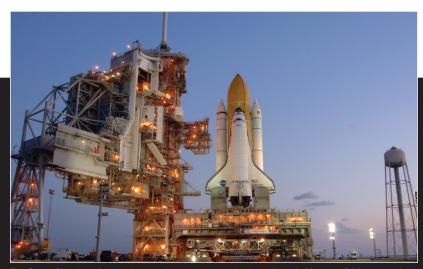
The Space Shuttle arrives at the launch pad, where payloads are installed into the Orbiter cargo bay.

Payloads were transported to the launch pad in a payload canister. At the pad, the canister was lifted with a 81,647-kg (90-ton) hoist and its doors were opened to the Payload Changeout Room—an enclosed, environmentally controlled area mated to the Orbiter payload bay. The payload ground-handling mechanism—a rail-suspended, mechanical structure measuring 20 m (65 ft) tall—captured the payload with retention fittings that used a water-based hydraulic system with gas-charged accumulators as a cushion. The mechanism, with the payload, was then moved to the aft wall of the Payload Changeout Room, the main doors were closed, and the canister

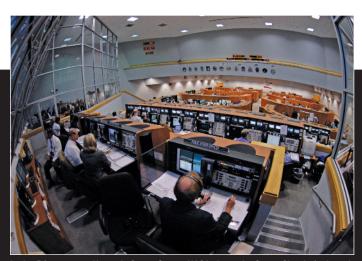
In the firing room at Kennedy Space Center, NASA clears the Space Shuttle for launch. STS-108 (2001) launch.

Launch was done by the software. If there were no problems, the button to initiate that software was pushed at the designated period called T minus 9 minutes (T=time). One of the last commands sent to the vehicle was "Go for main engine start," which was sent 10 seconds before launch. From that point on, the on-board computers were in control. They ignited the main engines and the SRBs.

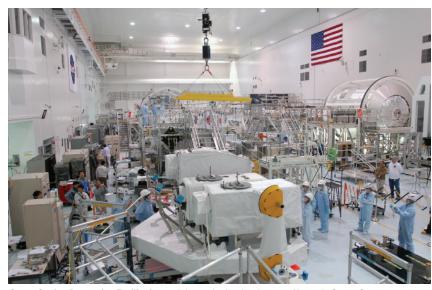
Space Station Processing Facility for modules and other hardware at Kennedy Space Center.

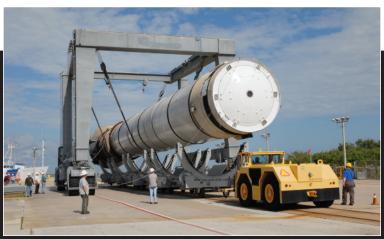
The recovered Solid Rocket Boosters are returned to Kennedy Space Center for refurbishment and reusability.

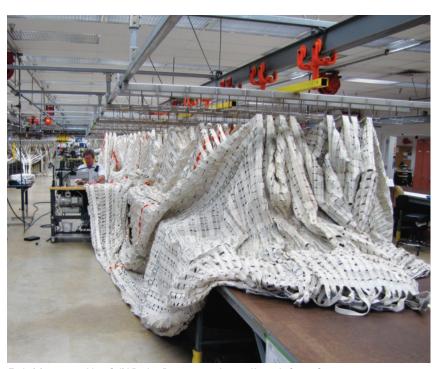
Technicians assemble a Solid Rocket Booster parachute at Kennedy Space Center.

At the facility, technicians unspooled, defouled, and inspected the parachutes. Following a preliminary damage mapping to assess the scope of repairs required, the parachutes were hung on a monorail system that facilitated movement through the facility. The first stop was a 94,635-L (25,000-gal) horizontal wash tank where each parachute underwent a 4- to 6-hour fresh water wash cycle to remove all foreign material. The parachutes were transferred to the drying room and

exposed to 60°C (140°F) air for 10 to 12 hours, after which they were inspected, repaired, and packed into a three-part main parachute cluster and transferred to the Assembly and Refurbishment Facility for integration into a new forward assembly.

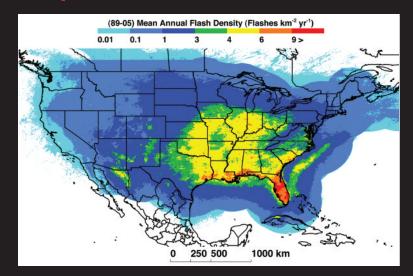
Lightning Flash Density at Launch Complexes

Flash density is a measure of how many lightning flashes occur in a particular area or location over time. Florida, and particularly the space launch complex, receives the highest density of lightning flashes in the contiguous 48 states. Review of lightning flash activity at the complex over many years shows that the highest average activity levels occur between June and September, and the lowest levels between November and January.

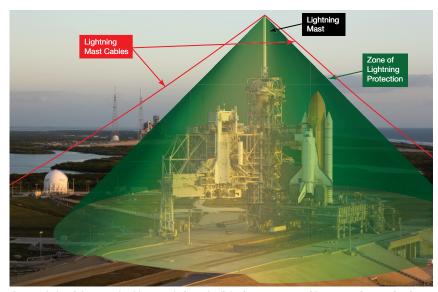
A grounded stainless-steel cable extends from the lightning mast to provide a zone of protection for the launch vehicle.

Physical lightning protection for the shuttle on the pad was provided by a combination of a large, loose network of wiring known as a counterpoise beneath the pad structure and surrounding environs and a large wire system comprising a 2.5-cm- (1-in.)-, 610-m-(2,000-ft)-long steel cable anchored and grounded at either end and supported in the middle by a 24.4-m- (80-ft)-tall nonconductive mast. The mast also served to prevent currents—from lightning strikes to the wire—from passing into the pad structure. A 1.2-m (4-ft) air terminal, or lightning rod, was mounted atop the mast and electrically connected to the steel cable. The cable arrangement assumed a characteristic curved shape to either side of the pad described mathematically as a catenary and therefore called the Catenary Wire System.

Additional lightning protection devices at the launch pads included a grounded overhead shield cable that protected the crew emergency egress slide wires attached to the fixed service structure. Grounding points on the pad surface and the mobile launcher platform and electrical connections in contact with the shuttle completed the system that conducted any lightning-related currents safely away from the vehicle. Overhead grid-wire systems protected hypergolic fuel and oxidizer storage areas. The huge 3,407,000-L (900,000-gal) liquid hydrogen and liquid oxygen tanks at each pad were constructed of metal and did not need overhead protection.
